# CITY OF WEST CHICAGO

## INFRASTRUCTURE COMMITTEE

**Thursday, March 4, 2021**  
**7:00 P.M. – Committee Room A**

500,000 Gallon Capacity  
Booster Number 4 Reservoir

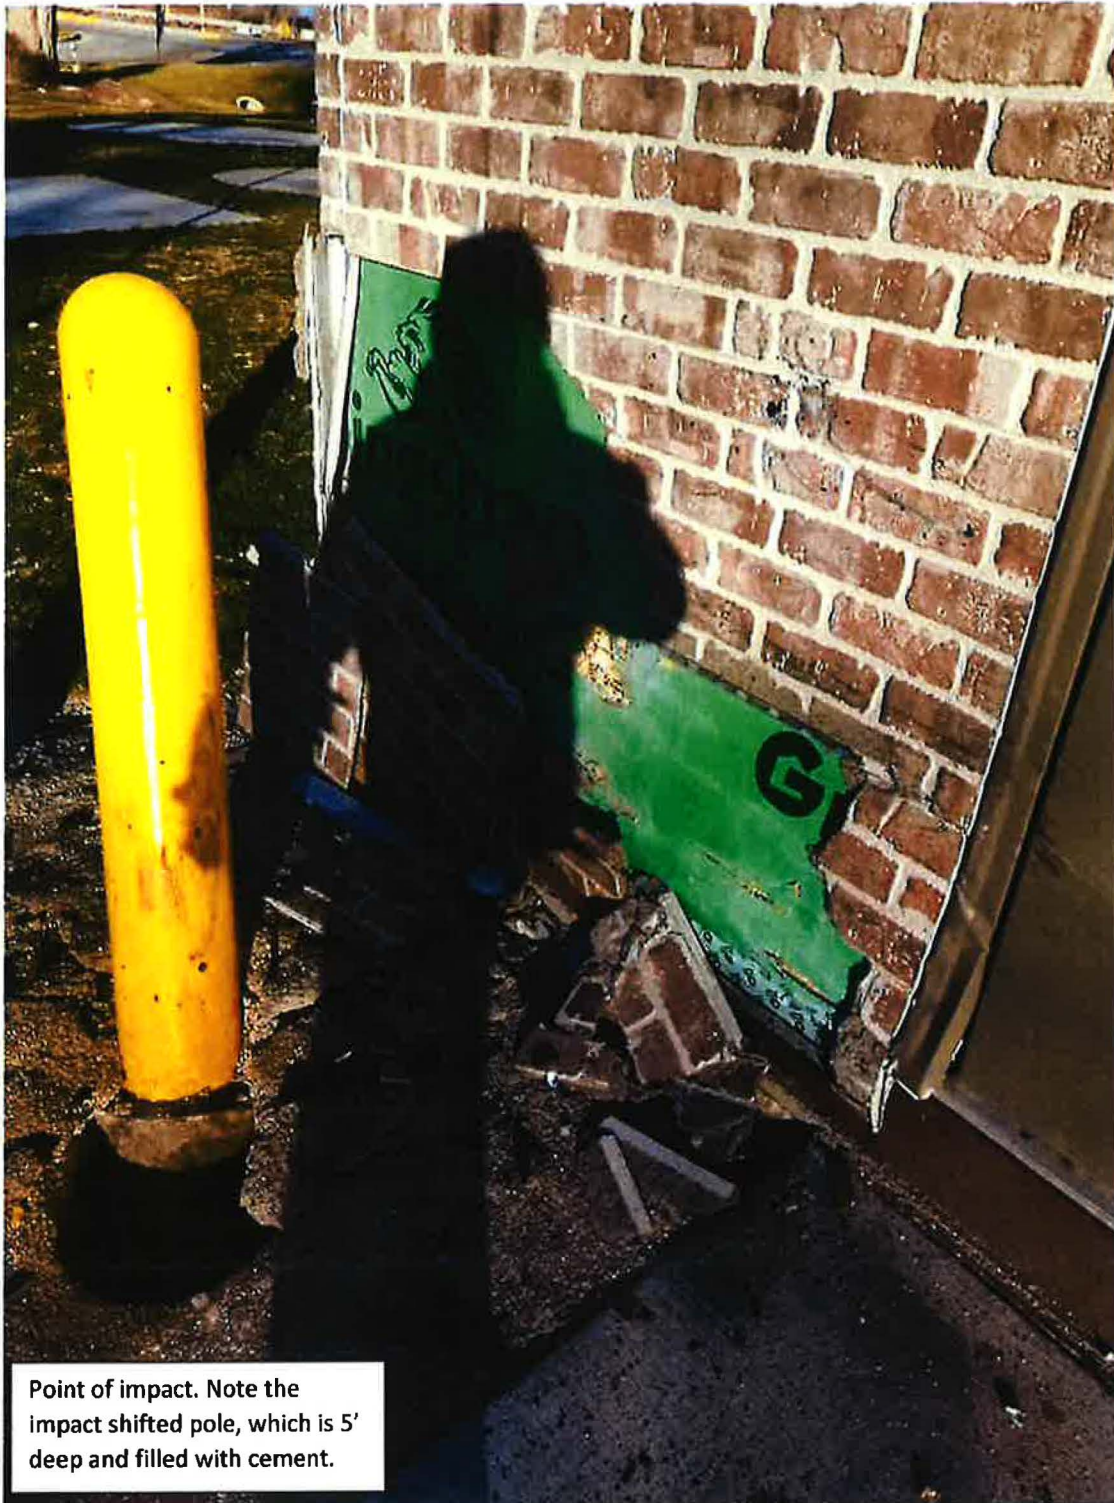
Point of impact. Note the impact shifted pole, which is 5' deep and filled with cement.

The City has completed the insurance claim process with the Intergovernmental Risk Management Agency (IRMA) and funds for repairs have been authorized. The control building at Lift Station #1 was originally constructed and installed by Starnet Technologies (Starnet) of Franksville, Wisconsin, and is modular in its construction (i.e., building components can be removed and replaced). As Starnet is most familiar with the building fabrication, City staff obtained a proposal from Starnet to complete repairs. Starnet's proposal, based on visible damages, is estimated at \$25,472.40. However, additional costs are anticipated once the exterior and interior panels are removed, the building is shifted back into place, and a structural inspection is completed.

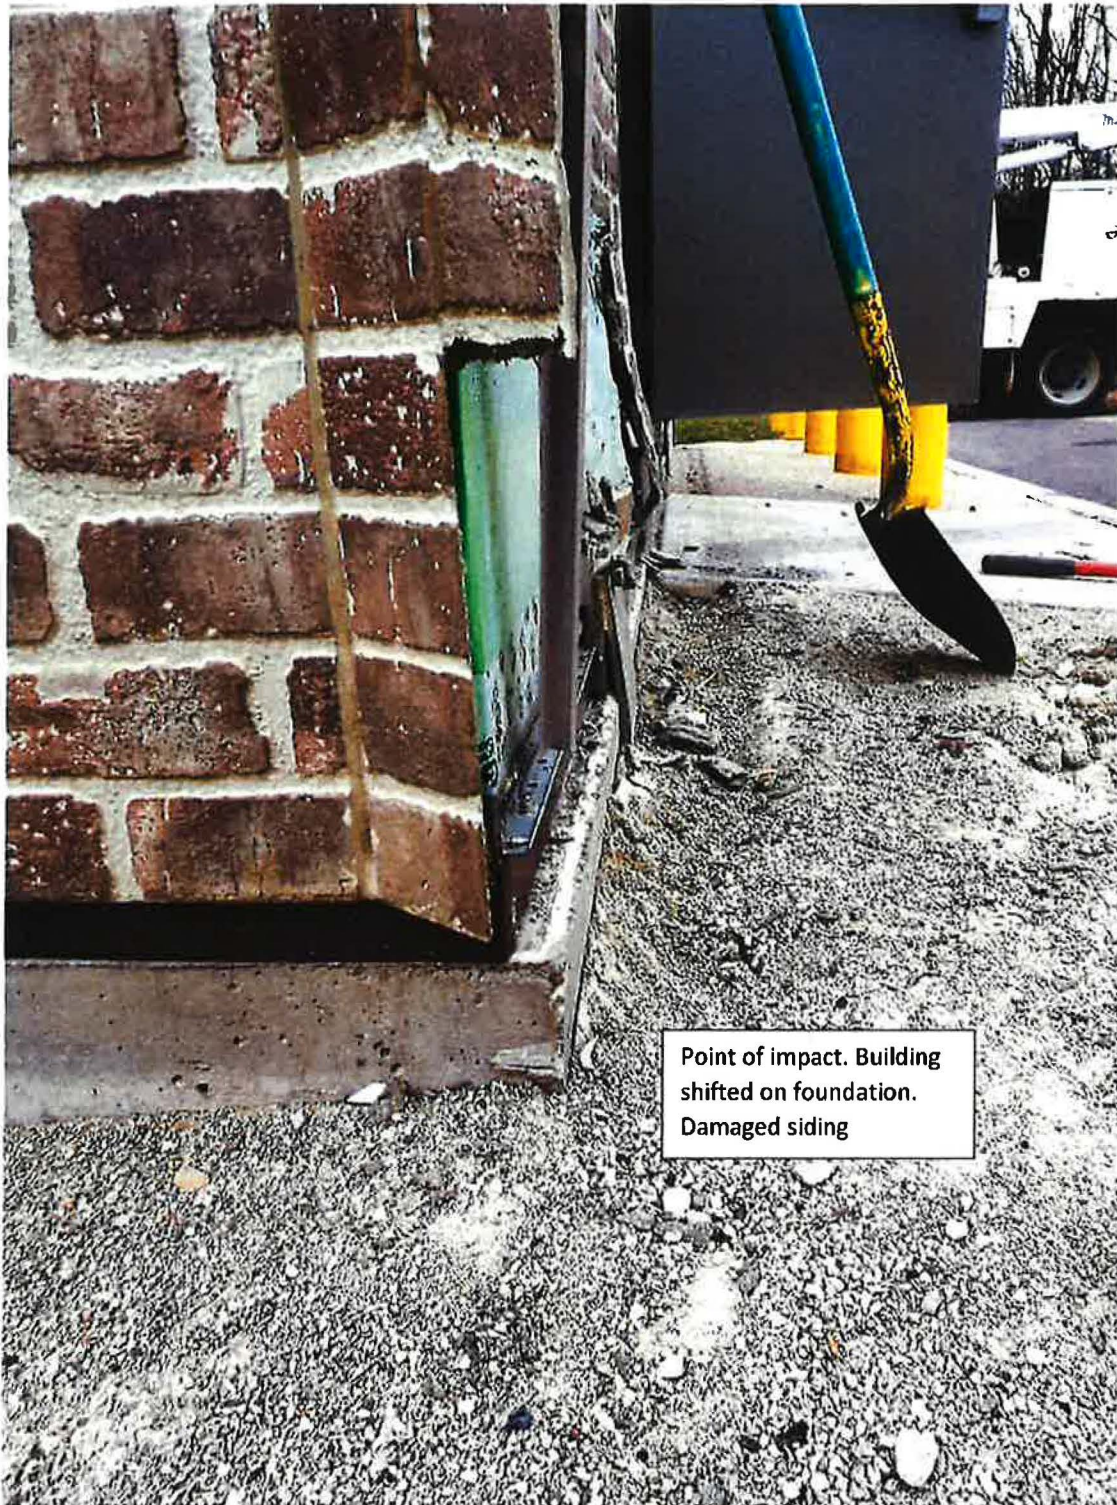
**12/25/2020 1450 S Neltnor Boulevard Lift Station #1 Accident Building Damage Photos**

Point of impact. Building shifted on foundation.  
Damaged siding

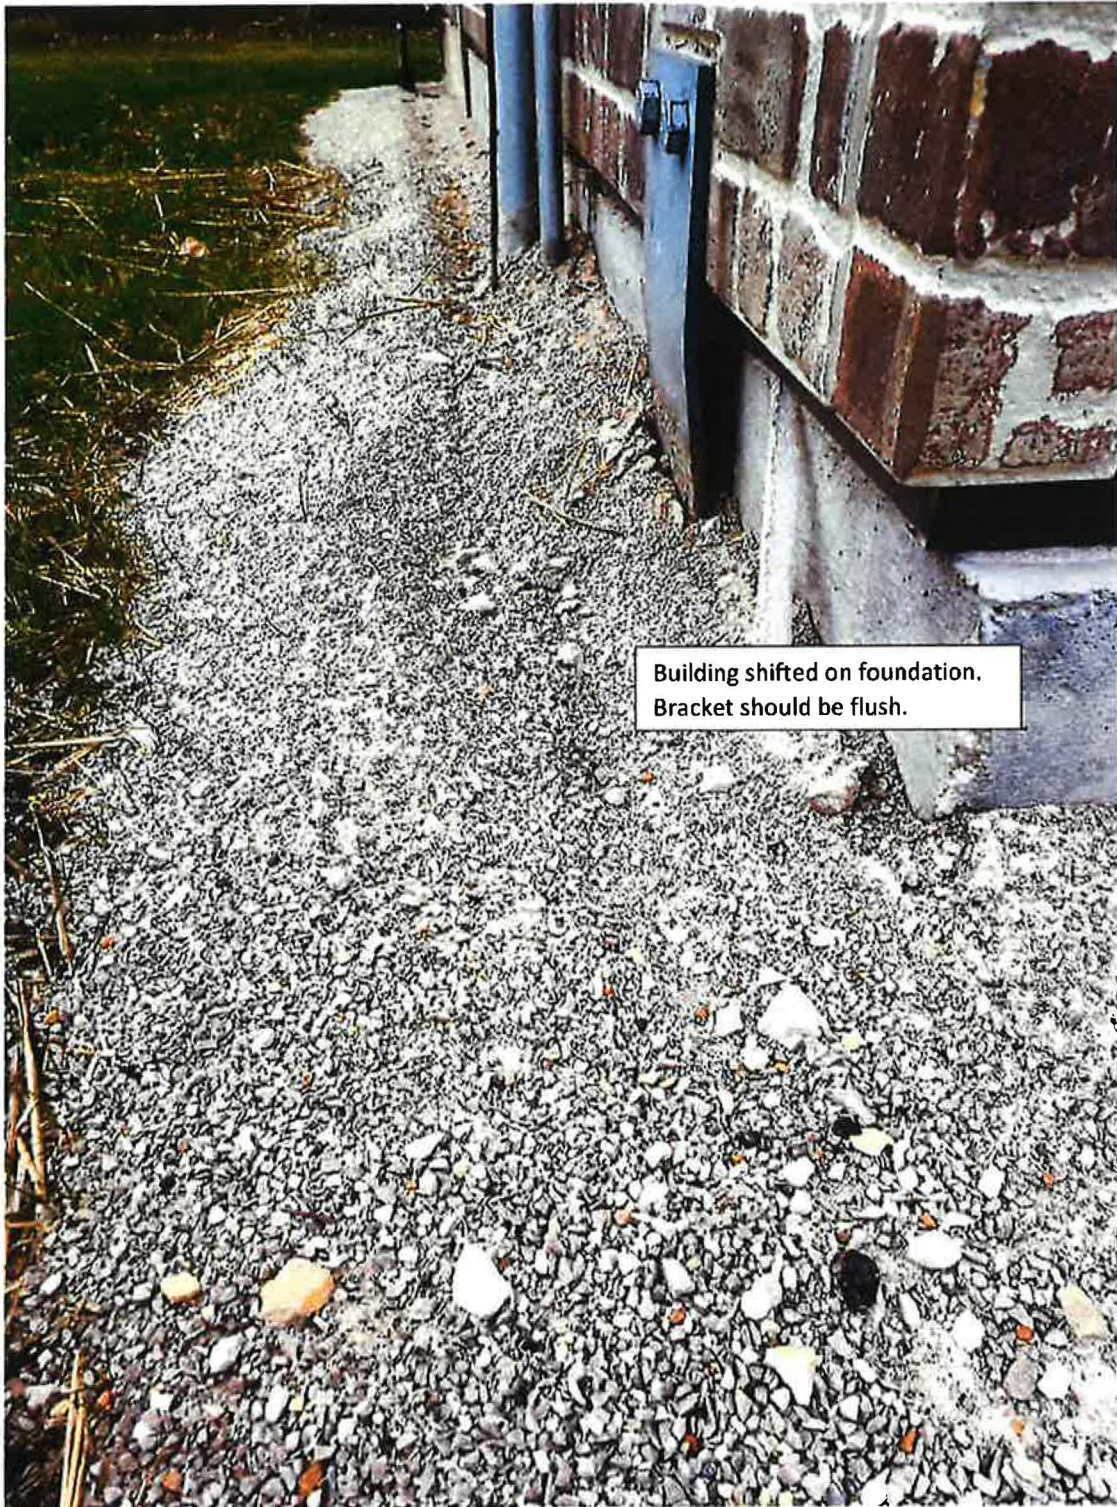
12/25/2020 1450 S Neltnor Boulevard Lift Station #1 Accident Building Damage Photos

Building shifted on foundation.  
Bracket should be flush.

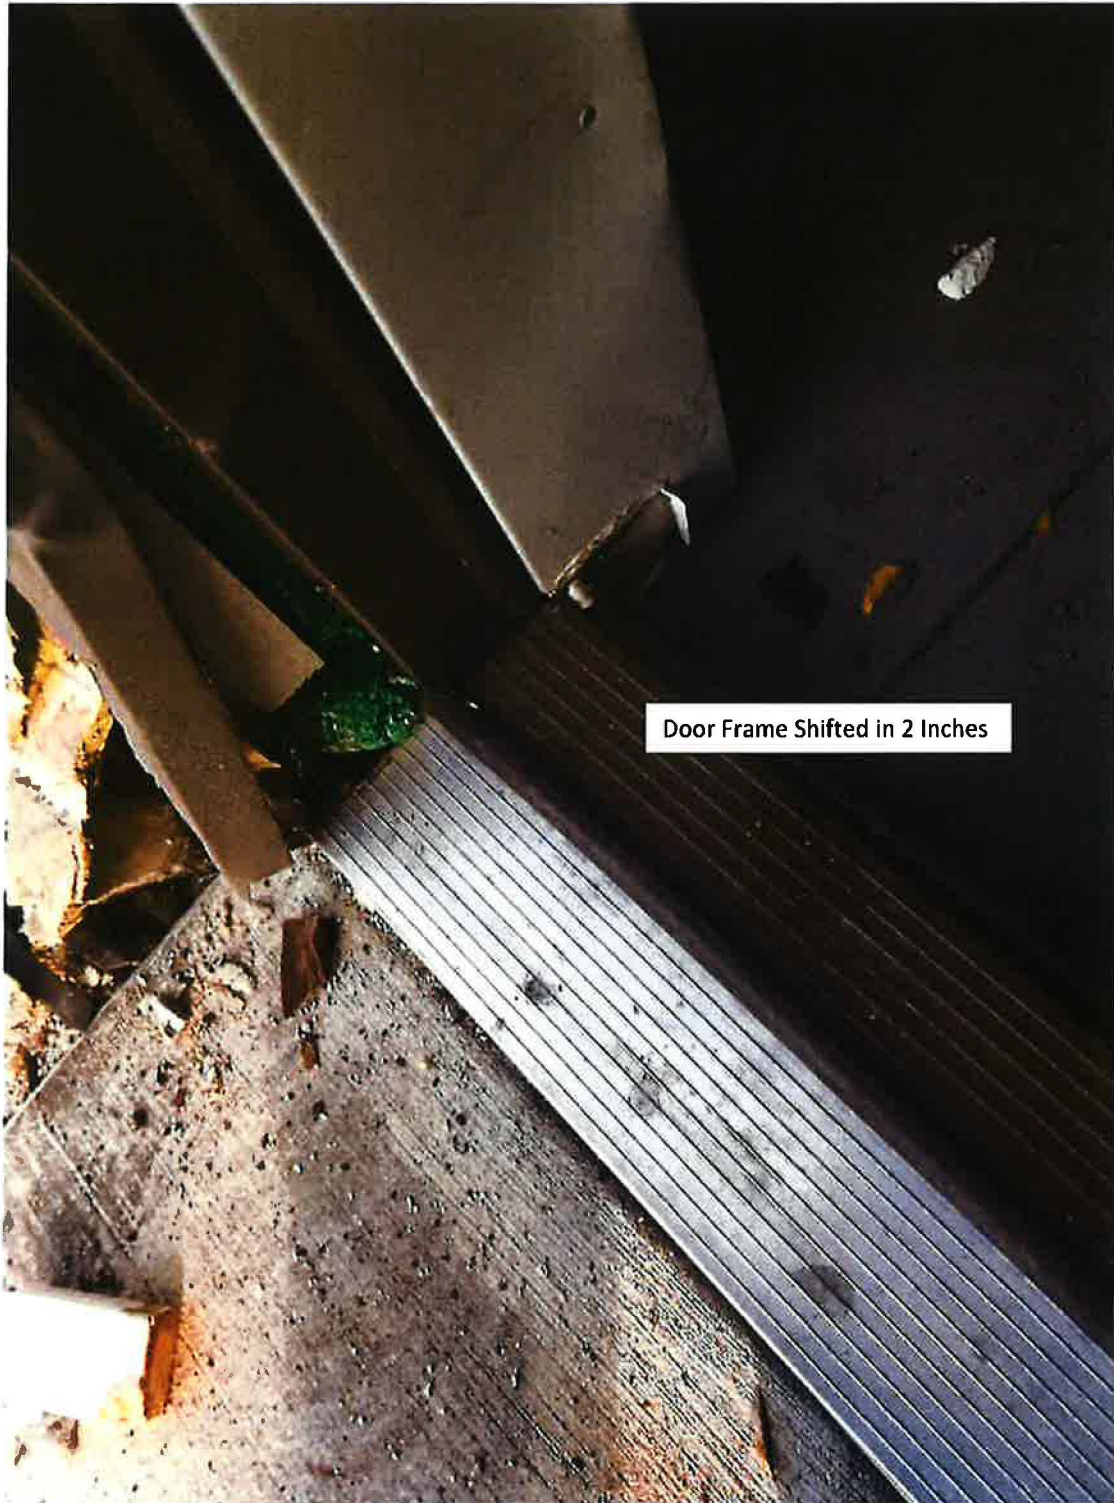
Door Frame Shifted in 2 Inches

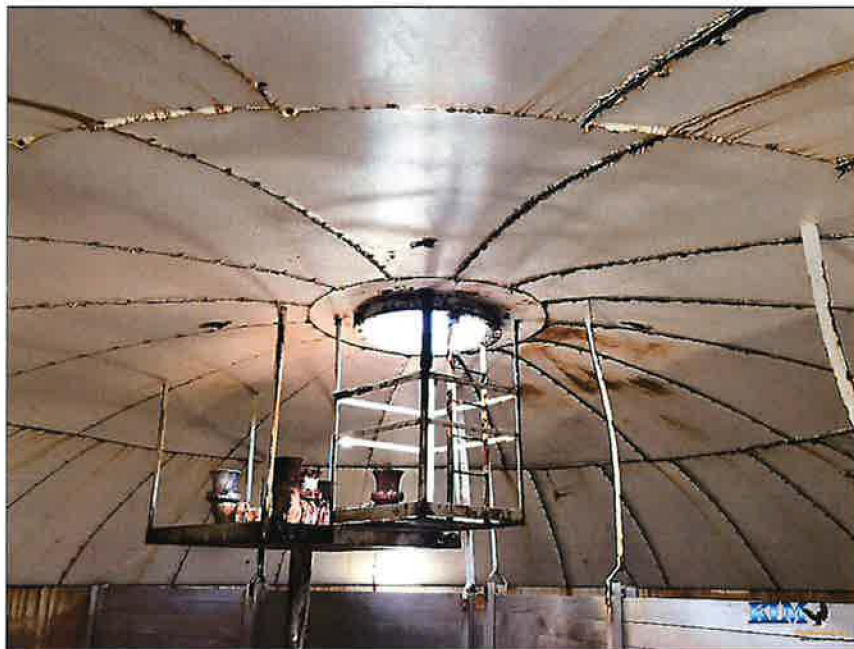
The roof of the Booster No. 4 reservoir is in unreparable condition. Although, it does not appear that the roof is caving in at the time of the evaluation, there is evidence of the interior of the roof plate edges deteriorating with severe corrosion. The evaluation was performed in May with good weather conditions, winter weather conditions and snow loads are unpredictable which may create considerable deflections. If left unattended the roof will continue to deteriorate depositing corrosion into water and when through corrosion occurs, contaminants can enter into the water and be in violation of AWWA and health department standards.

Currently corrosion has not visually appeared to affect the structural integrity of the roof. Although, corrosion has begun to migrate from the plate edges into base metal. If the corrosion is allowed to progress, it will diminish the structural strength of the roof. KLM does not have a history of the roof condition; therefore, a reasonable life prediction cannot be made at this time if no action is taken.

**Photo No. 2**  
**Overall roof condition, note center fill de-fuser and inspection platform**

The existing roof is not effectively repairable, replacing the entire roof and structure with a new steel roof (coated) is estimated at \$300,000 at current costs. As an option, the City of West Chicago may entertain replacing the steel roof with an aluminum geodesic domed roof for approximately \$375,000. An aluminum geodesic domed roof would require minimal maintenance over the life expectancy of the reservoir whereas reconditioning the interior and exterior of a steel roof can cost around \$100,000 every 25+- years. See photos 2 through 8.

- a. Diffuser inlets are typically installed to "aerate" water supply during the fill process to oxygenate water and allow iron to separate and settle to the floor. With a treatment plant, diffusers are normally not required. The existing supports for the platform are corroded beyond repair. Due to reoccurring maintenance costs, cost of replacing the support system and the fact that aeration only occurs while the reservoir is filling, repairing the existing fill pipe system and inspection platform is not recommended.

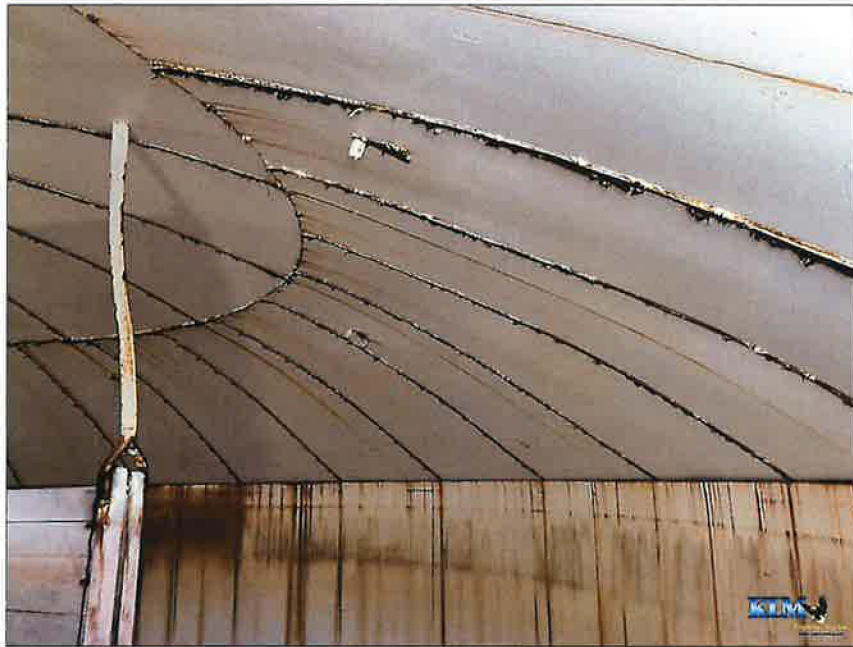
Photo No. 3  
Roof condition

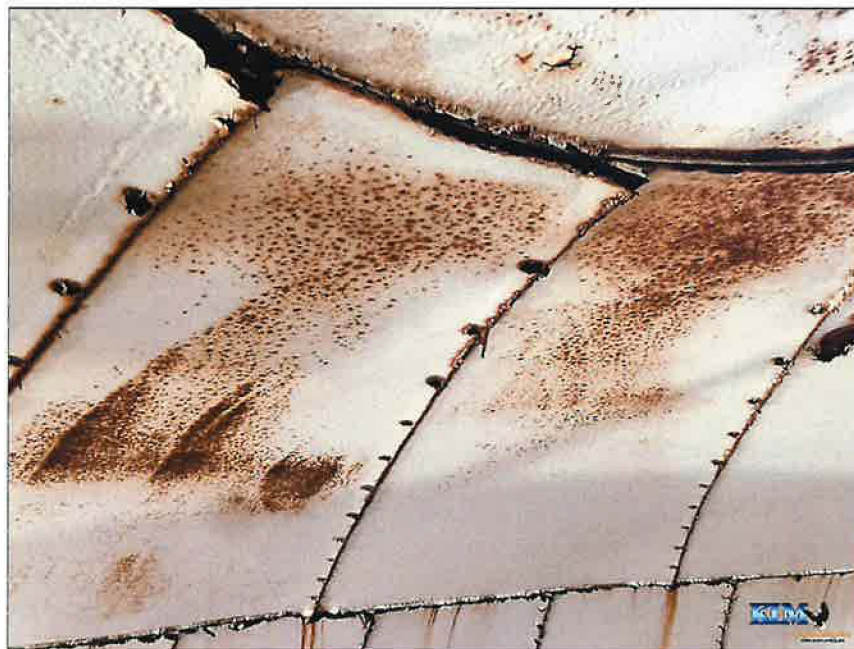
Photo No. 4  
Roof condition

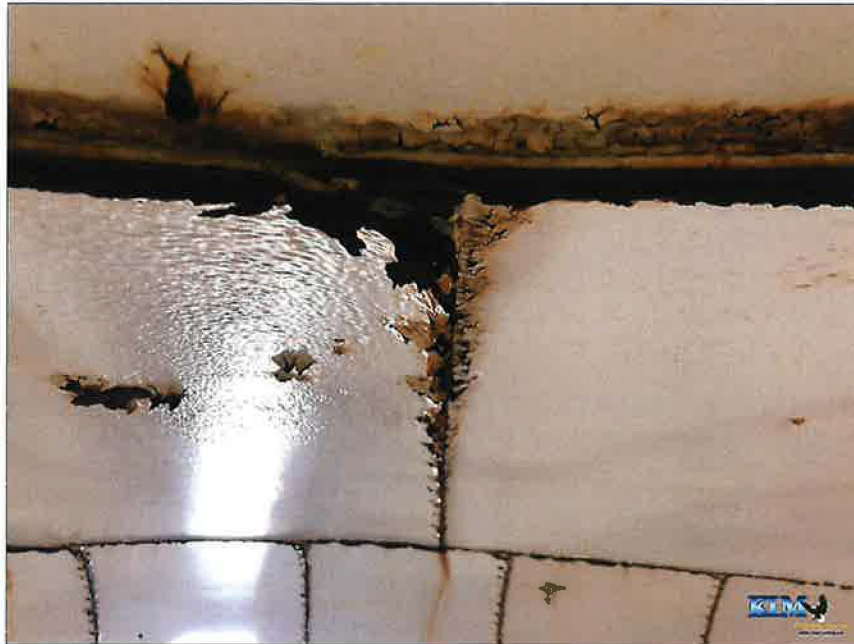
Photo No. 5  
Severe corrosion on roof plates

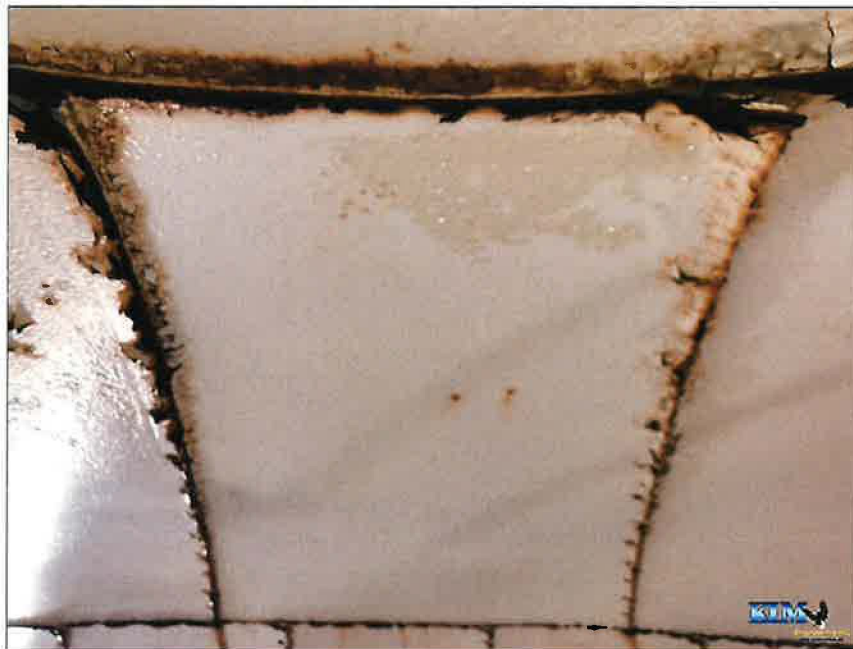
Photo No. 6  
Severe corrosion on roof plates

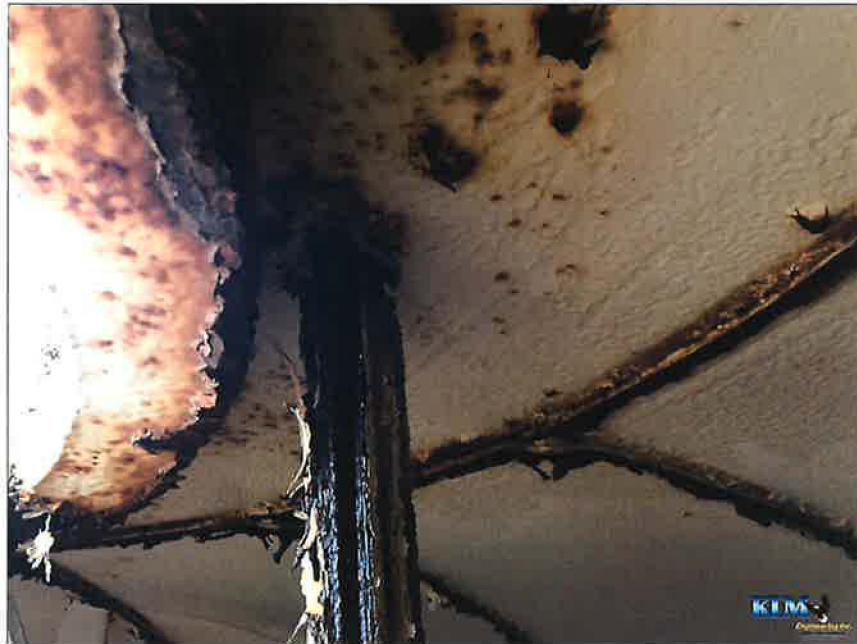
Photo No. 7  
Severe corrosion on inspection platform brace and dollar plate

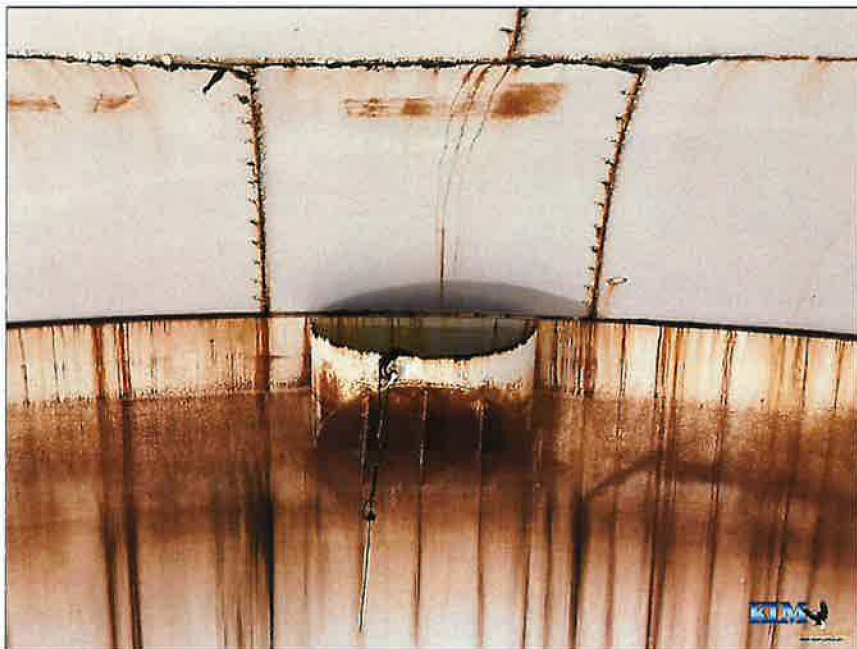
Photo No. 8  
Overflow weir box and roof/shell condition

- 3.1.6** Remove approximately 4-inches off the top of the overflow weir box to comply with AWWA D100-11 and State Health Codes. See photo 8.
- 3.1.7** Remove all erection brackets scab marks and weld spatter below the HWL by air arc gouging, cutting torch, or grinding. Repair the tank surface by welding and grinding outlined in Appendix C. See photos 20 through 22. This work will require approximately 75 man-hours.

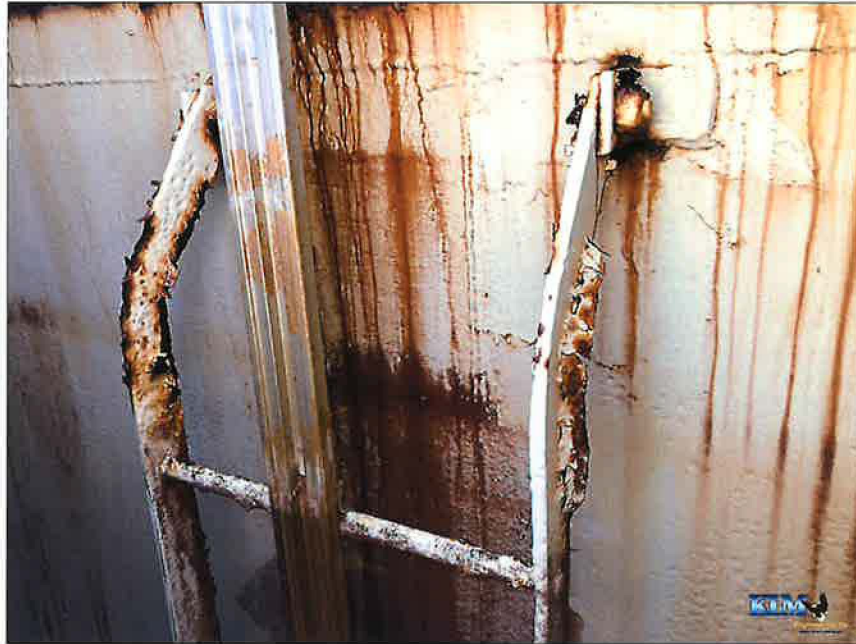
Photo No. 17  
Ladder condition at top of shell

- 3.1.8** Replace the top ten (10) feet of ladder and ladder stand-off brackets at the top of the shell. See photo 17.
- 3.1.9** Install a 12-inch tall removable silt stop to the top of the outlet pipe with welded flat bar tabs to keep it in place. Install two bars on top of the new silt stop. The silt stop will help keep sediment from entering the water stream and the bars will hinder the entry of miscellaneous material and provide a safety measure. See photo 25.

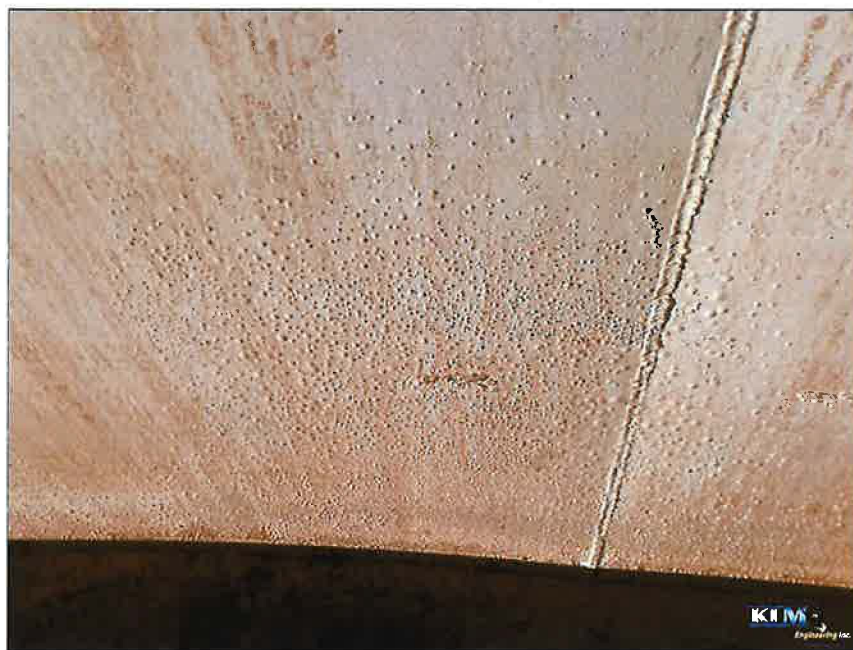
**3.2.1** The interior wet coating is in poor condition above the High-Water Line (HWL) with approximately 50 percent visible coating failures including severe corrosion at each lap plate seam. The roof has structurally deteriorated beyond the point of repair. Due to deterioration, condition and non-compliance with AWWA and State Health Codes the roof should be replaced with an aluminum geodesic dome style roof within the next 12 months to ensure continued use of the reservoir as designed. The coating below the HWL is in poor overall condition with approximately 50 percent visible coating failures consisting of widespread rust nodules and solvent entrapment blisters. Due to condition the coating below the HWL is not repairable and should be replaced in its entirety at the same time as installation of the geodesic dome roof within 12 months. See photos 2 through 26.

Photo No. 20  
Shell coating condition, note blisters and erection scab marks

**3.2.2** After structural repairs are completed, all the reservoir surfaces should be abrasive blasted to an SSPC-SP-10 Near White Metal Blast and coated with a light-colored zinc/polyamide epoxy system (similar to the Tnemec Series 91-H20 Hydro-Zinc/Series N140 Pota-Pox Plus Epoxy coatings).

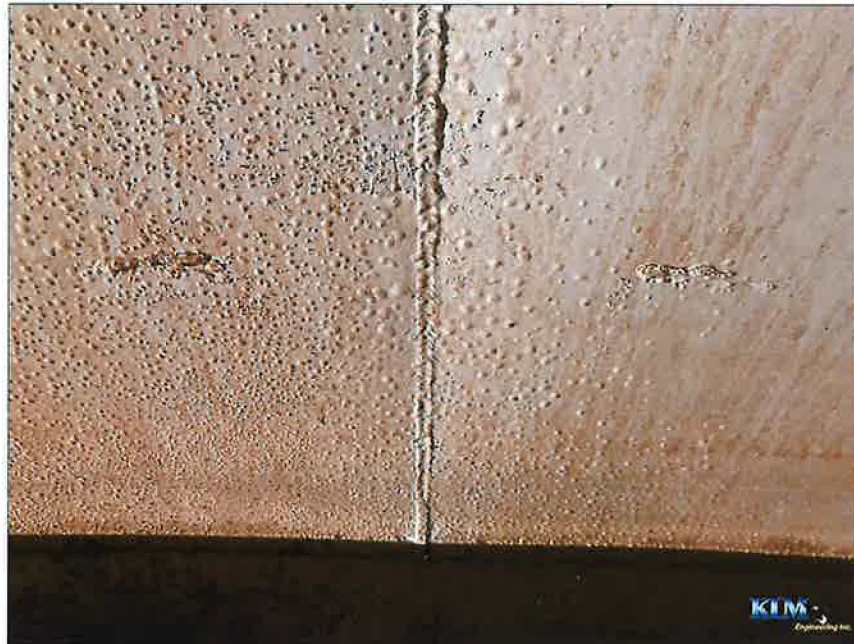
Photo No. 21  
Erection scab marks and blistered coating on shell

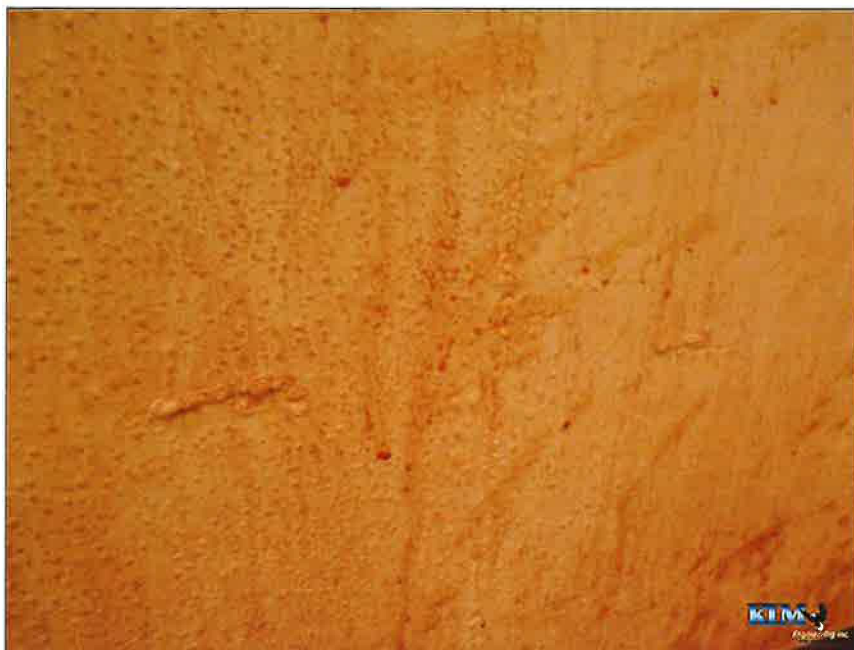
Photo No. 22  
Erection scab marks and blistered coating on shell

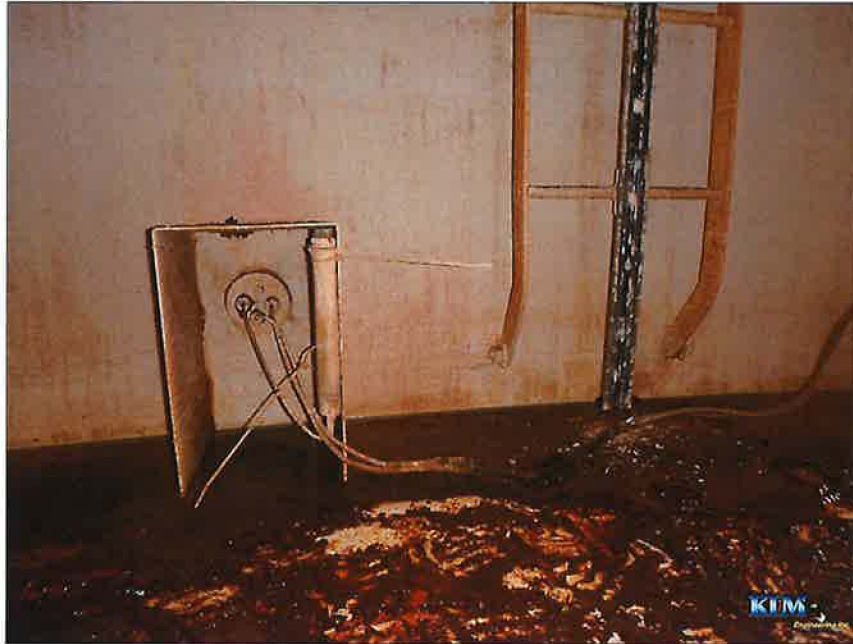
Photo No. 23  
C.P. penetration on shell and floor conditions

- 3.1.4** Remove the Cathodic Protection System in its entirety including the housing around the shell penetration and wall clips. Repair the resulting hole in the shell per AWWA D100-11. See photos 23, 26 and 37.

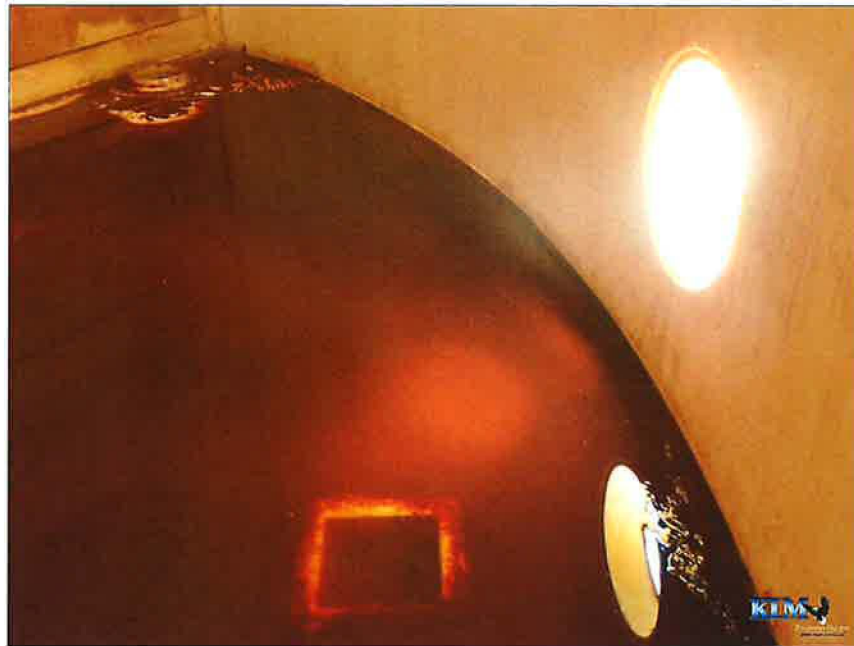
Photo No. 25  
Floor conditions, note sump pit and shell manway

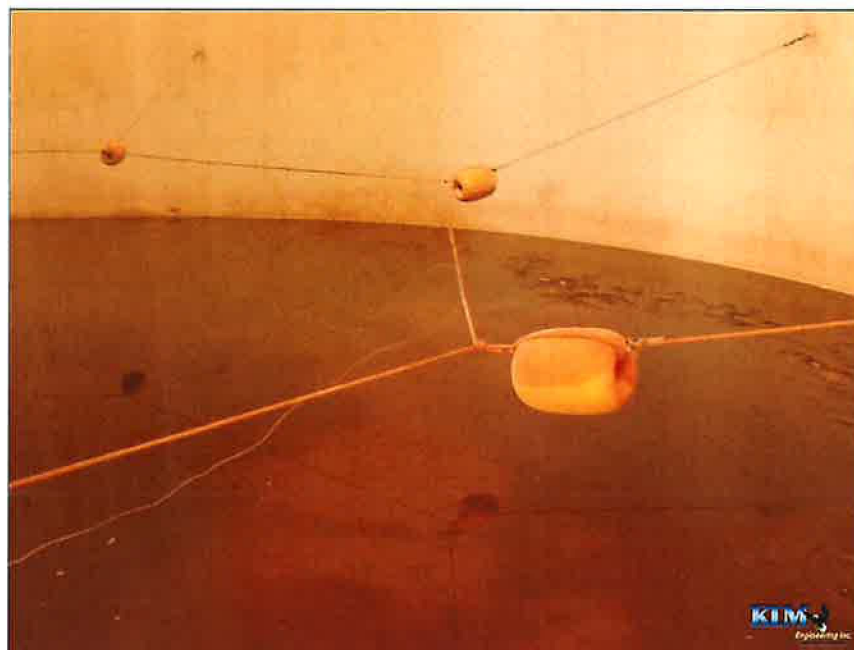
**3.3.1** The submerged style Cathodic Protection System is recommended to be removed in its entirety per Item 3.1.5 above. Current coating conditions suggests that the Cathodic Protection System is not working correctly.

Photo No. 26  
C.P. system and floor conditions

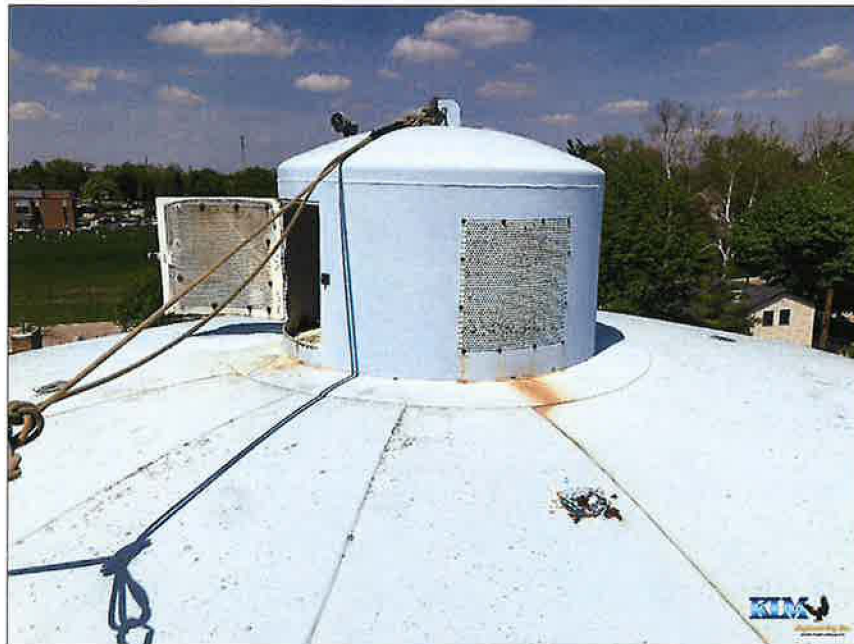
**3.5.1** The exterior coating is in poor overall condition with more than 50 percent visible coating failures throughout the structure. Failures consist of rust nodules caused by deterioration of the topcoat exposing the underlying epoxy to UV conditions. Due to age and condition the exterior is not a candidate for spot repair or over-coating and should be replaced in its entirety at the same time as the interior coating within the next 12 months. This includes the piping in the valve pit. See photos 27 through 41.

Photo No. 27  
Non-compliant finial vent and roof conditions

**3.5.2** After structural repairs are completed, all the reservoir surfaces should be abrasive blasted to an SSPC-SP-6 Commercial Blast Clean and coated with a zinc/epoxy/urethane/fluoropolymer system (similar to the Tnemec Series 91-H20 Hydro-Zinc/Series N140 Pota-Pox Plus Epoxy/Series 73 Endurashield/Series 701 Hydroflon coatings).

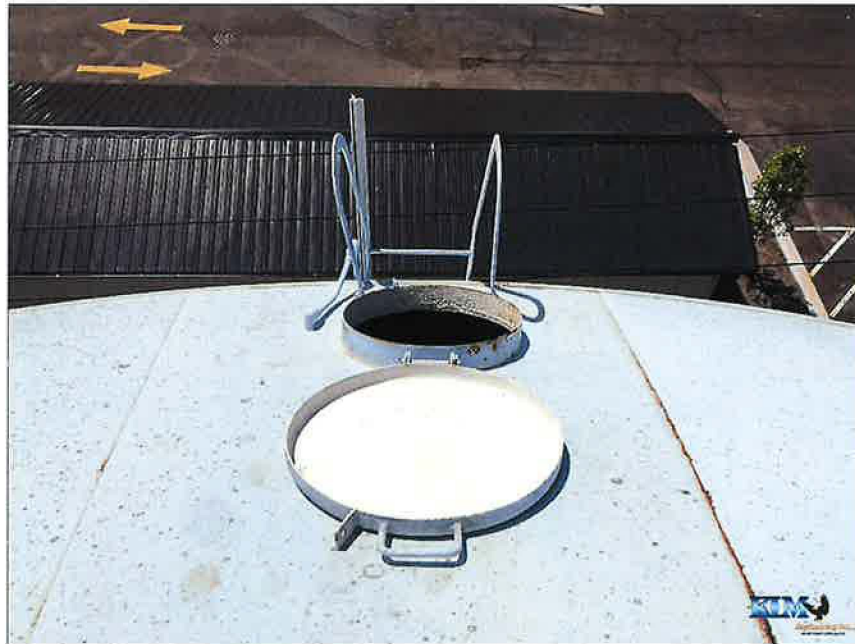
Photo No. 31  
Note shell ladder location in reference to roof access manway

**3.4.1** Relocate the exterior shell ladder approximately three (3) feet either side of its existing location. The ladder is currently aligned with the roof access manway creating unsafe access into the wet area. This item may not be required if the manway on the new geodesic dome roof is located See photos 31 and 32.

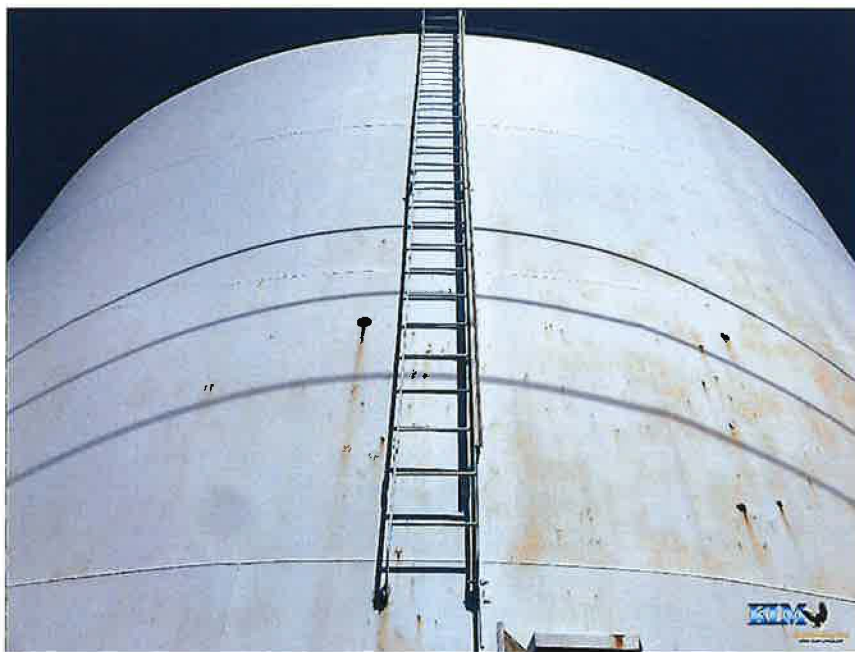
Photo No. 32  
Shell ladder and coating conditions

**3.4.5** Replace the flat track safety climb device on the shell ladder with an OSHA compliant cable style safety climb device. See photo 32 and KLM Drawing No. 24

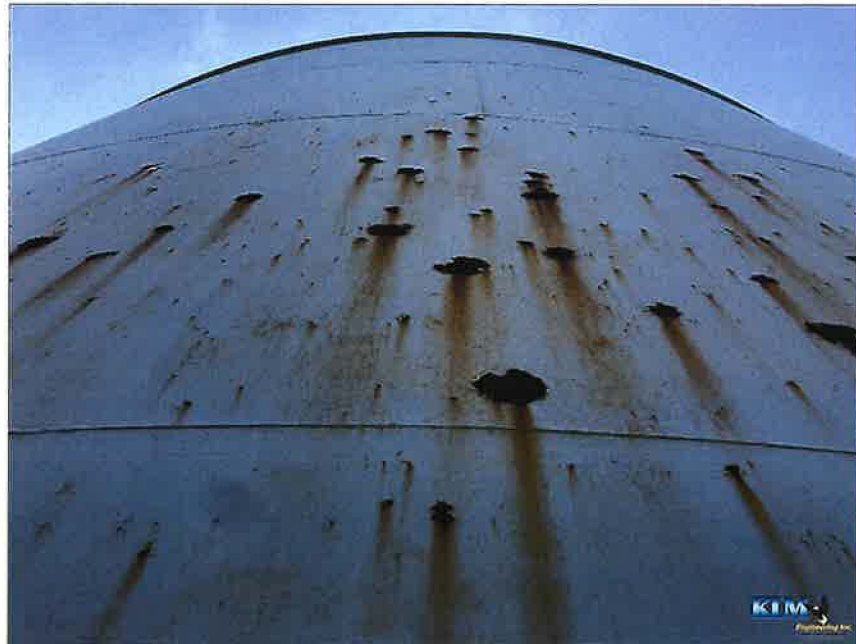
Photo No. 33  
Shell coating condition

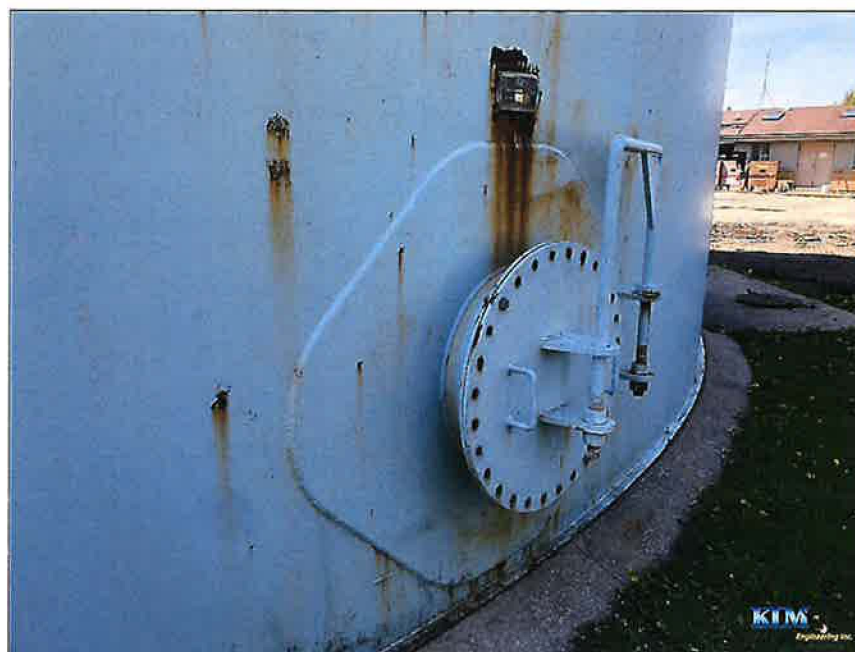
Photo No. 34  
Shell manway

**3.4.2** Replace the two (2) shell manway gaskets. See photos 34 and 36.

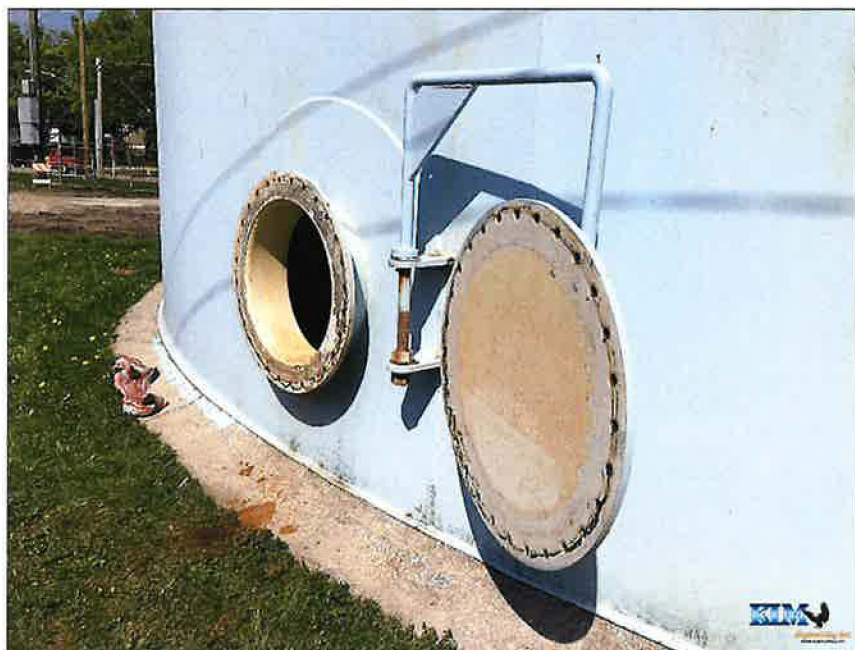
Photo No. 36  
Shell manway and foundation conditions

**3.4.3** Replace missing Flexcell under the base plate of the reservoir. Epoxy caulk around the entire perimeter of the seam between the concrete and base plate using Sika-Flex 1-A or approved equal. See photos 36 through 39.

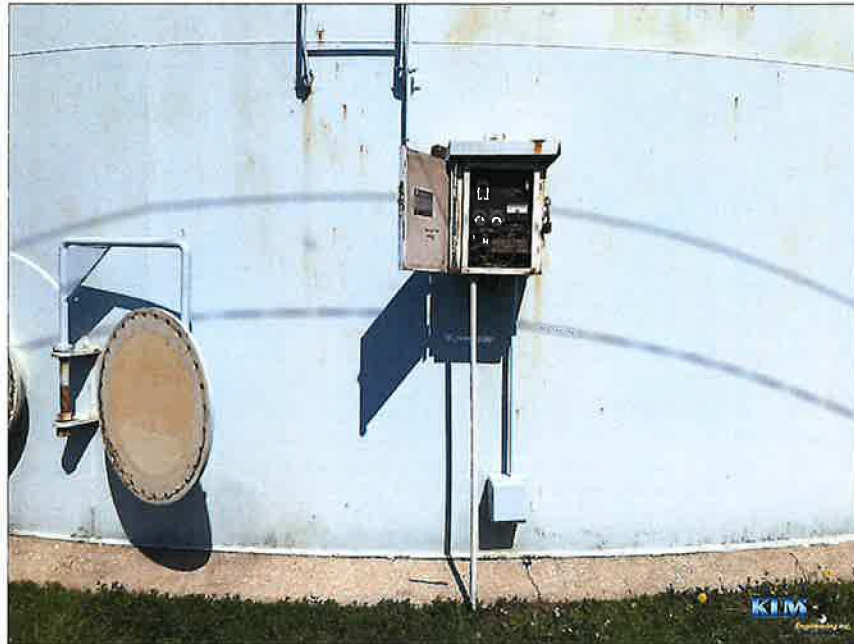
Photo No. 37  
C.P. rectifier and shell conditions

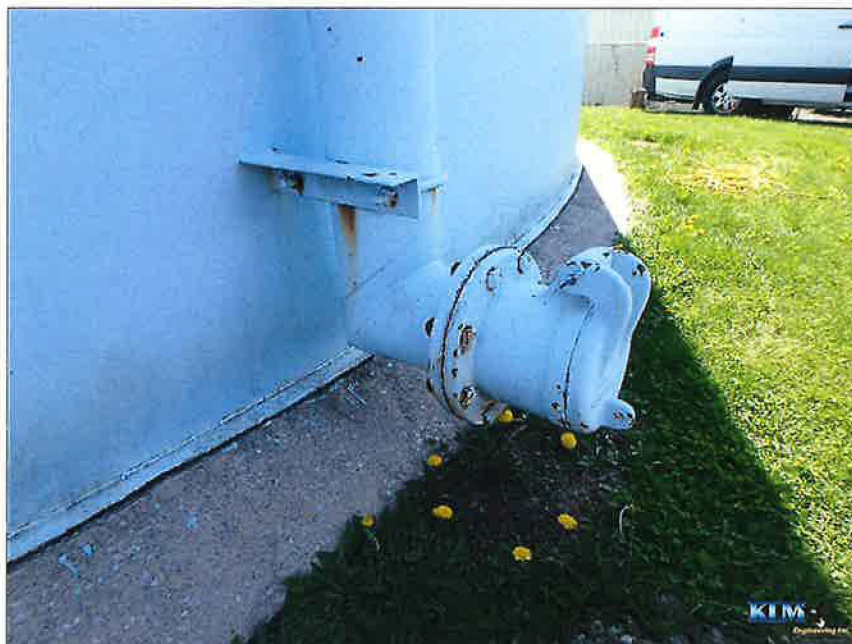
Photo No. 39  
Overflow discharge, note missing flex cell at chime base

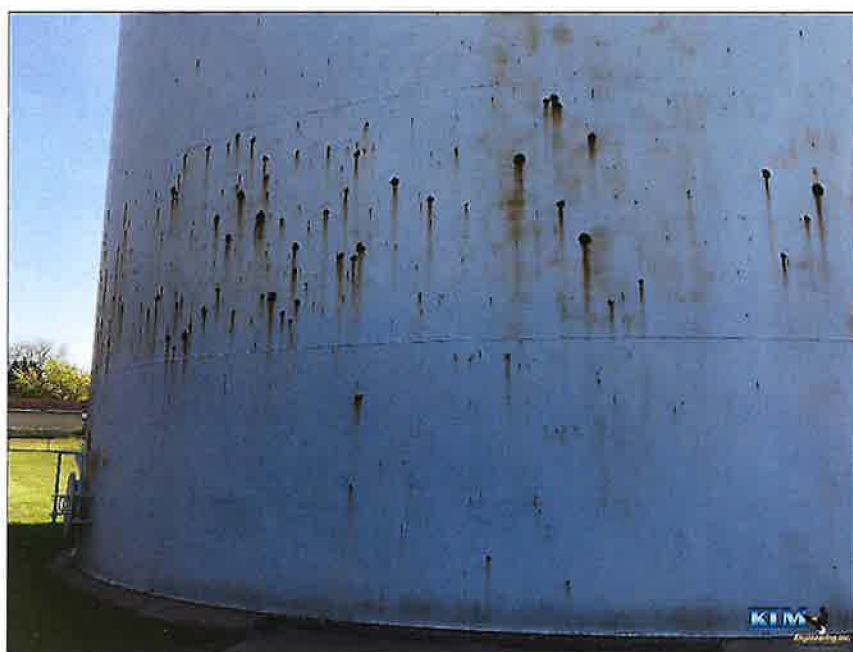
Photo No. 40  
Shell coating condition

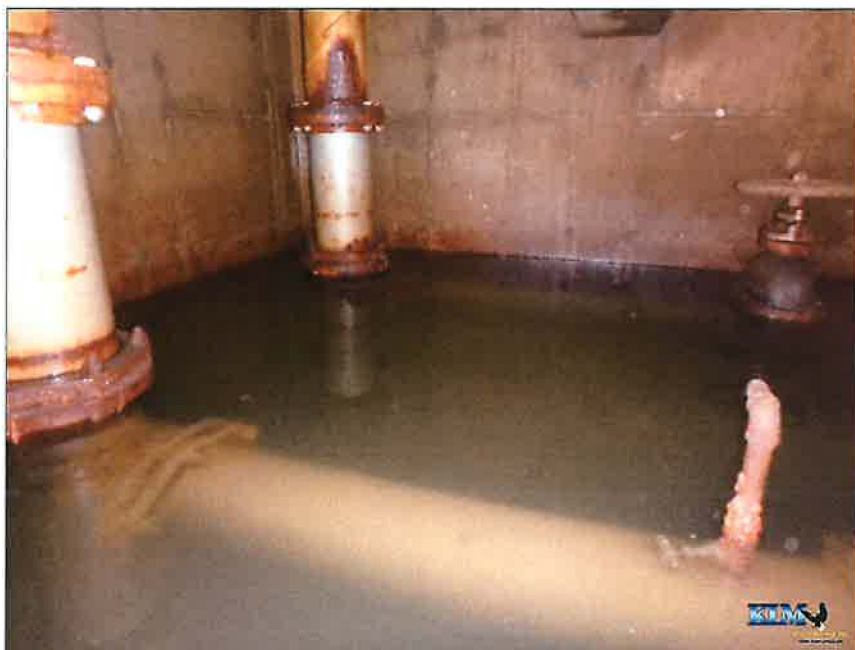
Photo No. 42  
Valve pit and piping conditions
