# CITY OF WEST CHICAGO

## INFRASTRUCTURE COMMITTEE

**Thursday, March 4, 2021**  
**7:00 P.M. – Committee Room A**

500,000 Gallon Capacity  
Booster Number 4 Reservoir

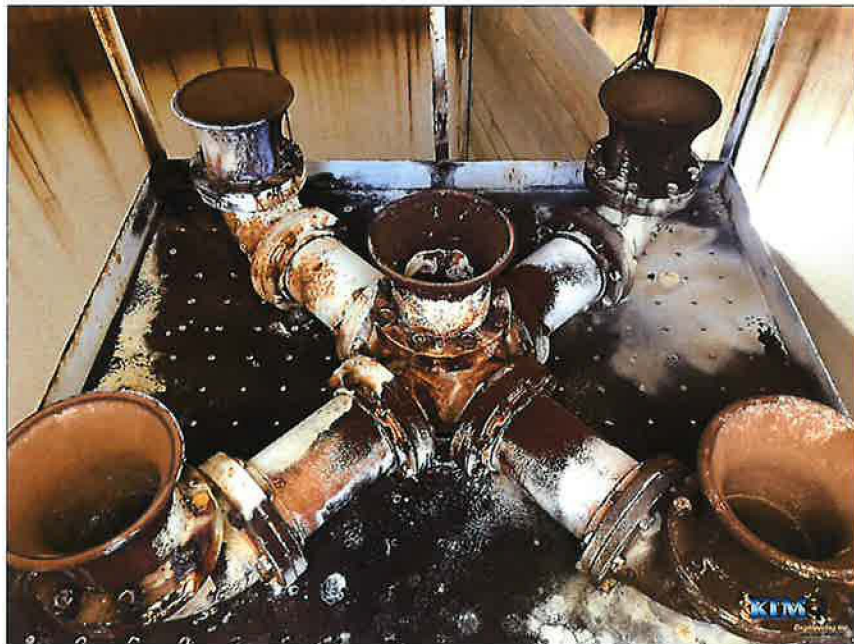
Photo No. 9  
Fill pipe and de-fuser plate

- 3.1.1** Remove the inspection platform and fill pipe de-fuser platform under the center of the roof. See photos 2, 7, and 9 through 11.
- 3.1.2** Remove the fill pipe down to a point approximately three (3) feet above floor level. Install a brace connecting the pipe to the floor at the 90-degree connection of the pipe. See photos 10 through 12.

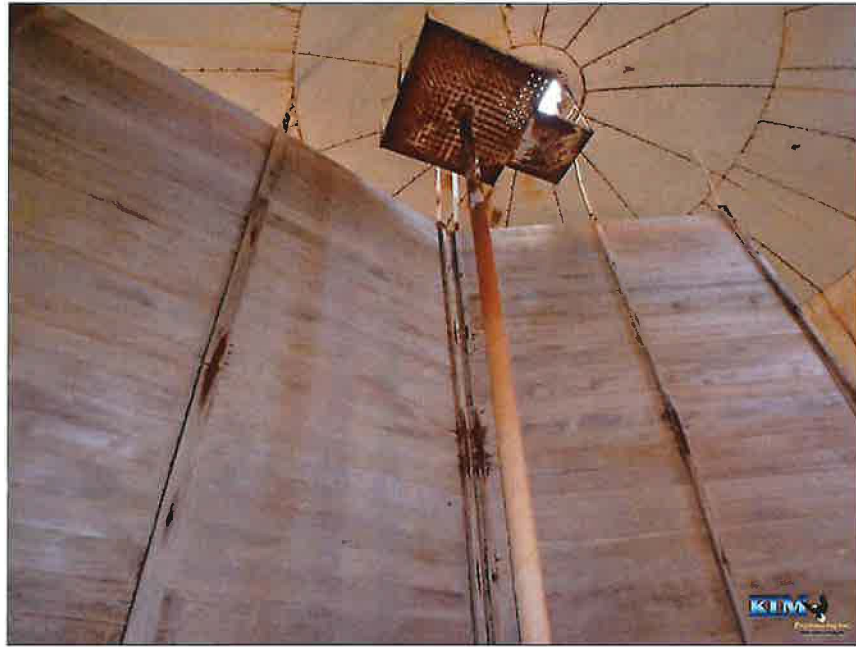
Photo No. 11  
Fill pipe and baffle wall

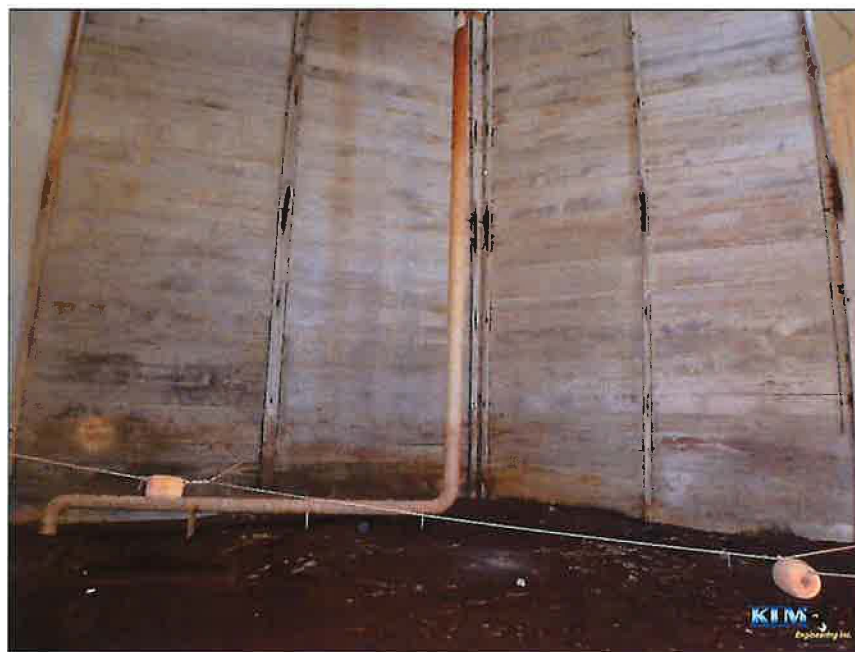
Photo No. 12  
Fill pipe and baffle wall

- 3.1.3** Remove the wood plank baffle wall and all connection points. Grind smooth all attachment points to the wall and floor per Appendix C. Typically baffle walls are installed to direct even distribution of sediment. It is not required with proper mixing systems and scheduled cleanout inspections. See photos 12 through 15.

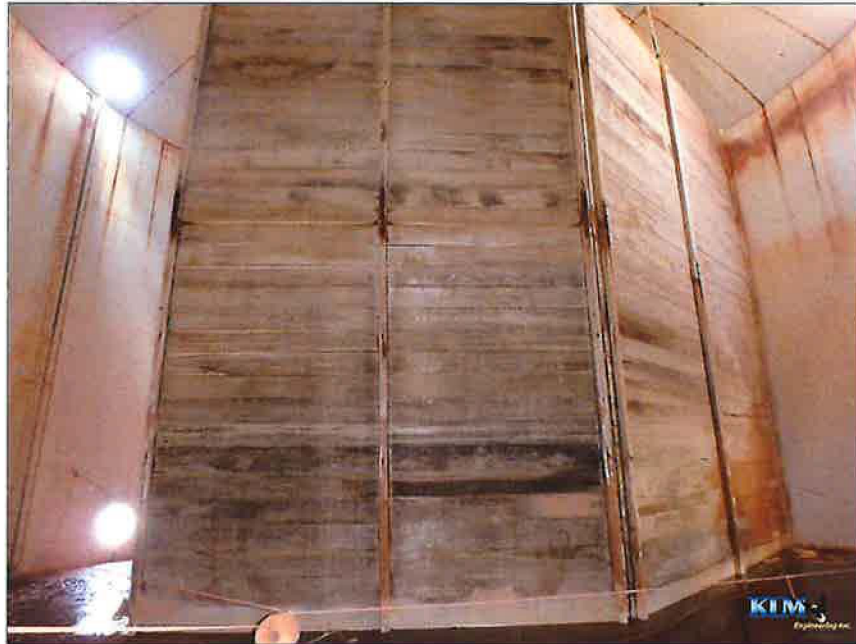
Photo No. 13  
Wood plank baffle wall

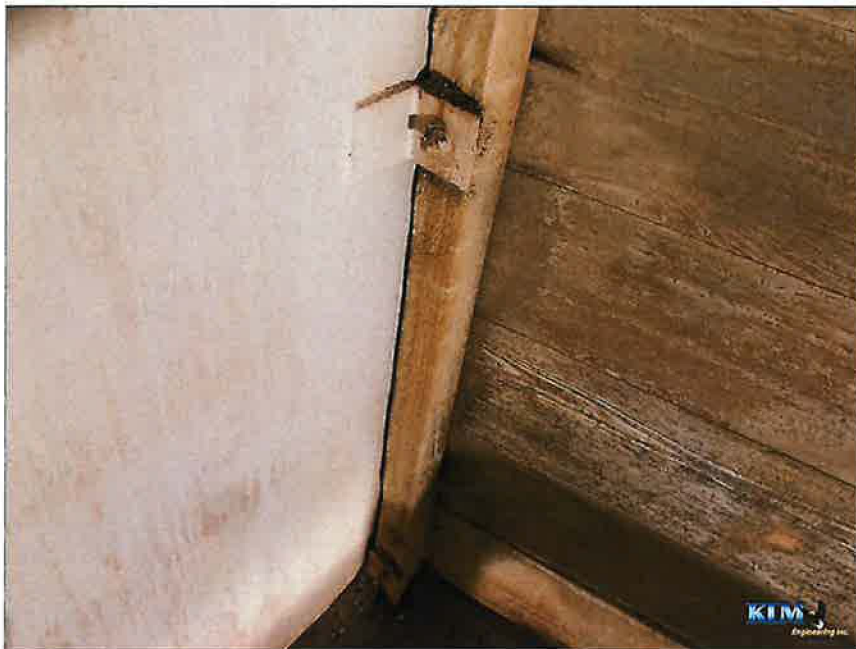
Photo No. 14  
Baffle wall connection to reservoir shell

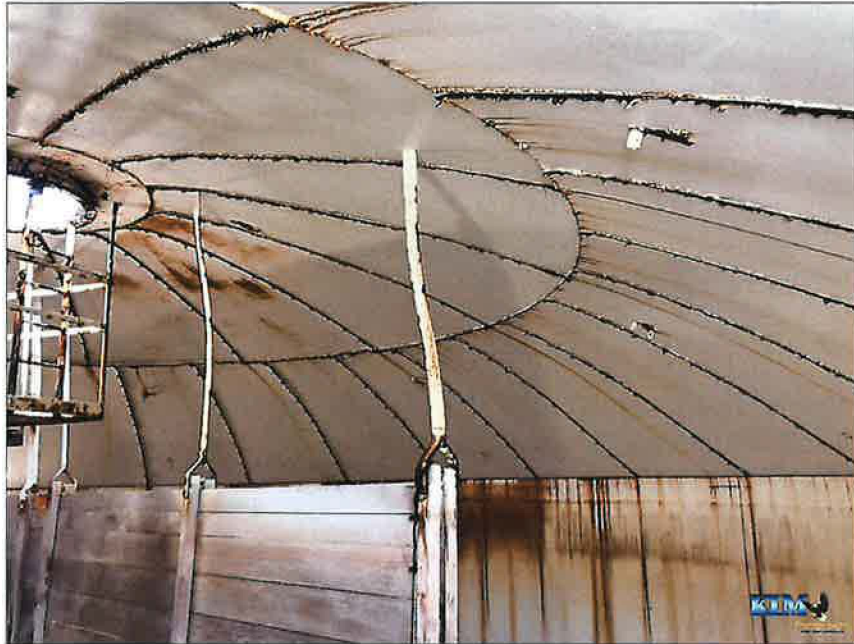
Photo No. 15  
Baffle wall connection to roof

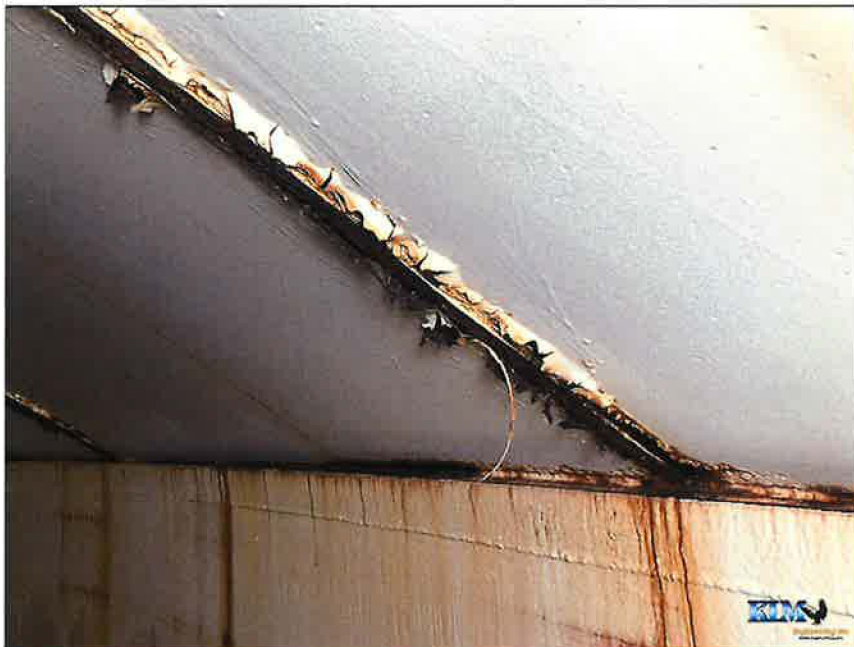
Photo No. 16  
Roof to shell connection and conditions

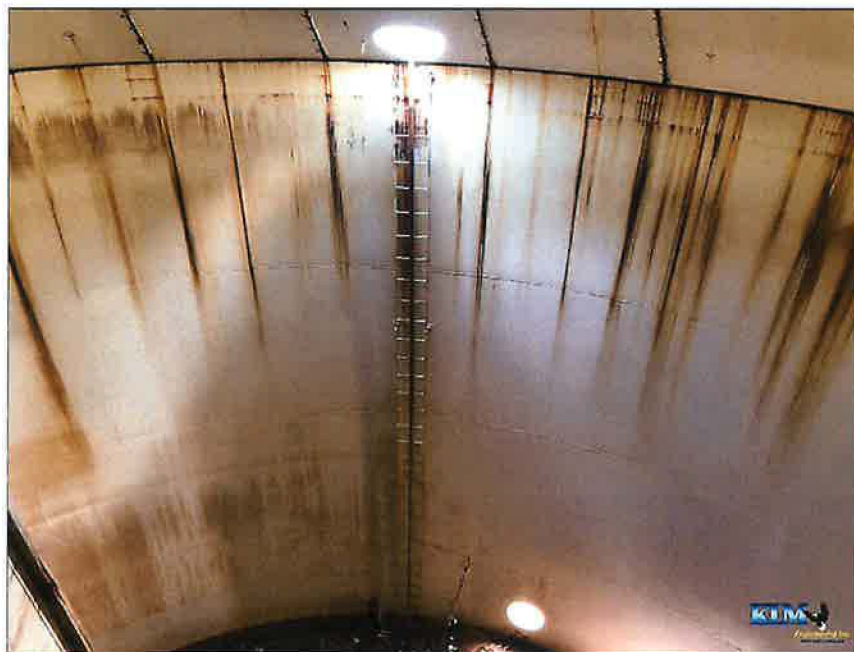
Photo No. 18  
Overall condition of shell

- 3.1.5** Remove the ladder safety climb device. Install an anchor point and Self Retracting Lifeline (SRL) on the underside of the roof adjacent to the access manway for safe egress into the reservoir. See photos 17 and 18 and KLM Drawing No. 26.

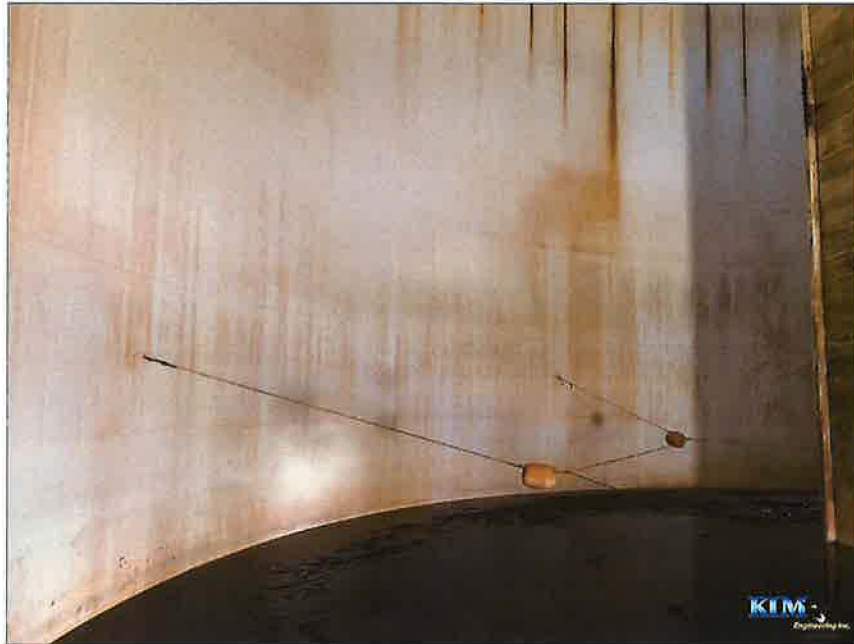
Photo No. 19  
Shell condition, note C.P. system

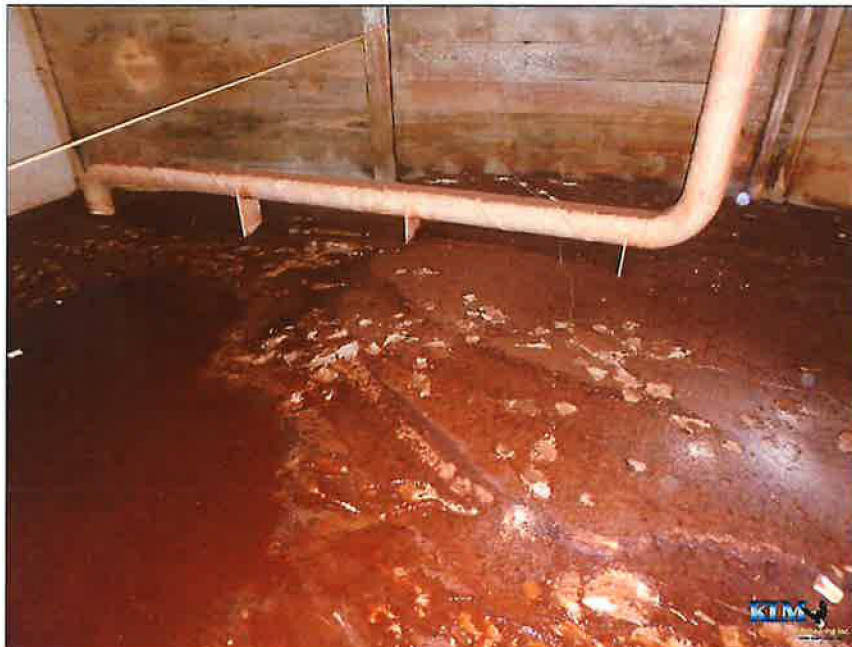
Photo No. 24  
Floor conditions and inlet pipe

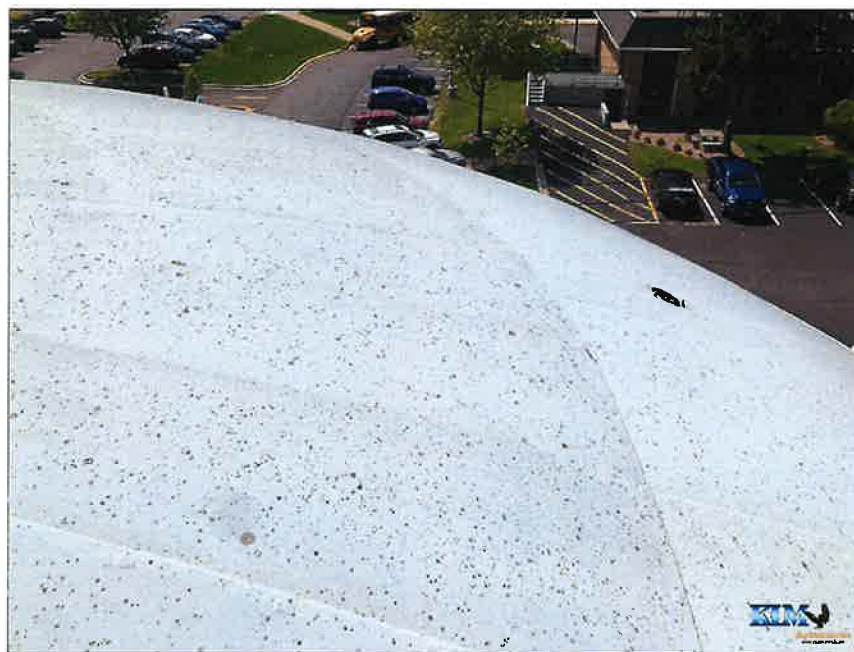
**3.5.1** The exterior coating is in poor overall condition with more than 50 percent visible coating failures throughout the structure. Failures consist of rust nodules caused by deterioration of the topcoat exposing the underlying epoxy to UV conditions. Due to age and condition the exterior is not a candidate for spot repair or over-coating and should be replaced in its entirety at the same time as the interior coating within the next 12 months. This includes the piping in the valve pit. See photos 27 through 41.

Photo No. 28  
Overall roof conditions

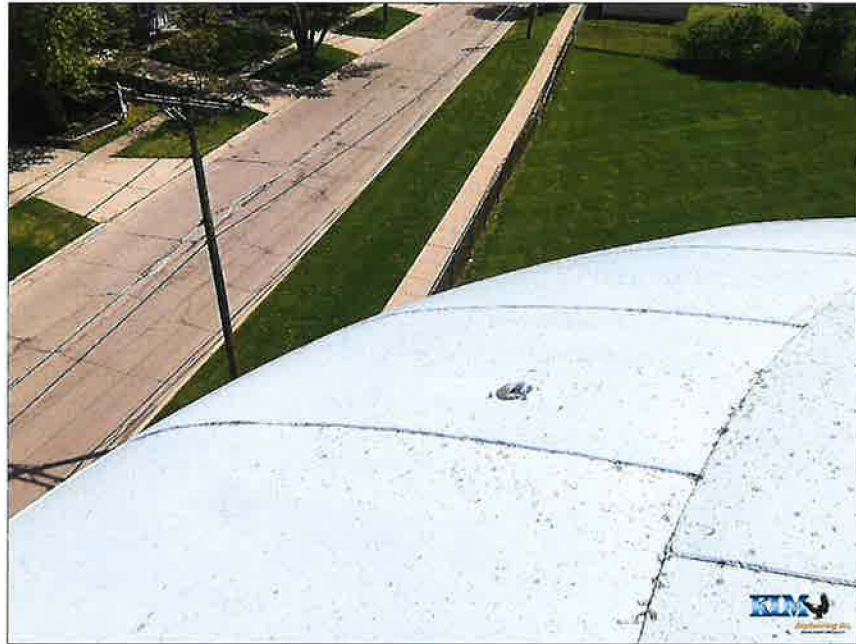
Photo No. 29  
Roof conditions

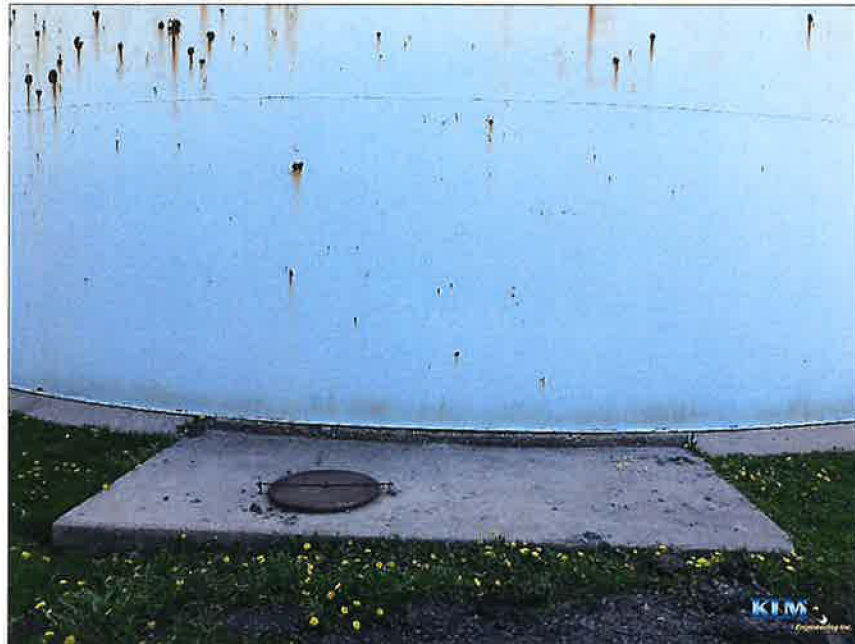
Photo No. 41  
Valve pit roof and access manway

**3.4.7** Install a sump pump including electrical connections required for proper operation in the valve pit. The discharge shall be routed through the roof of the valve pit and directed away from the base of the reservoir. See photos 41 and 42.
