# CITY OF WEST CHICAGO

## INFRASTRUCTURE COMMITTEE

**Thursday, March 4, 2021**  
**7:00 P.M. – Committee Room A**

500,000 Gallon Capacity  
Booster Number 4 Reservoir

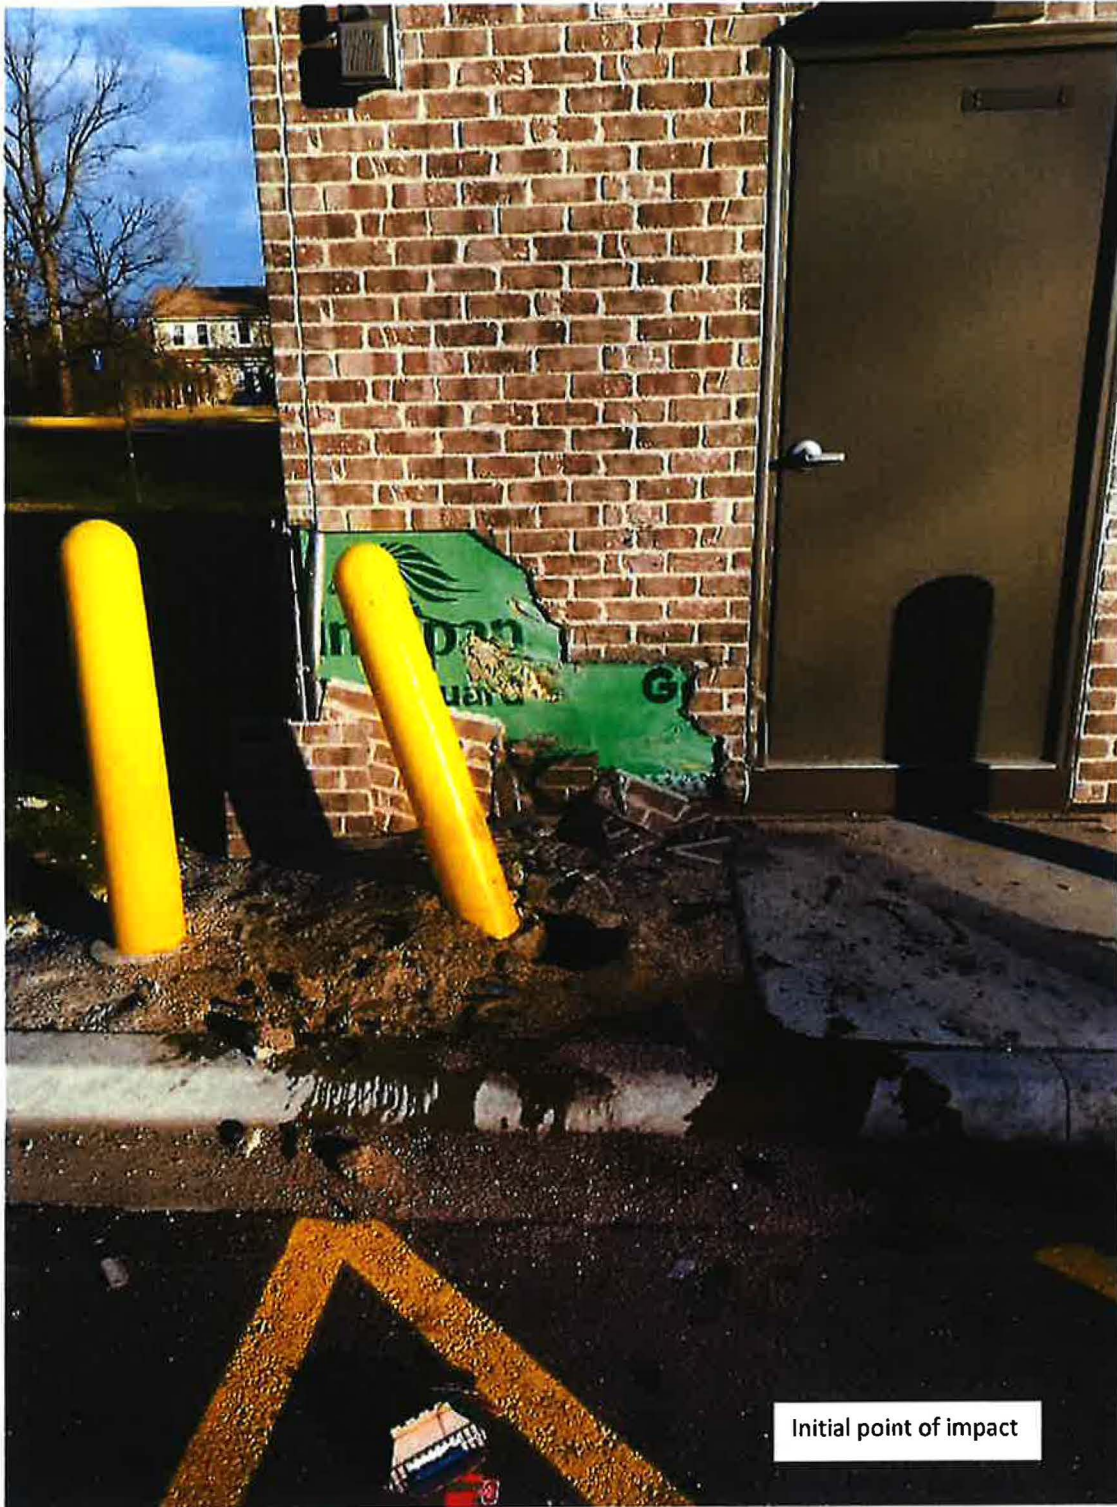
12/25/2020 1450 S Neltnor Boulevard Lift Station #1 Accident Building Damage Photos

Point of impact. Note the impact shifted pole, which is 5' deep and filled with cement.

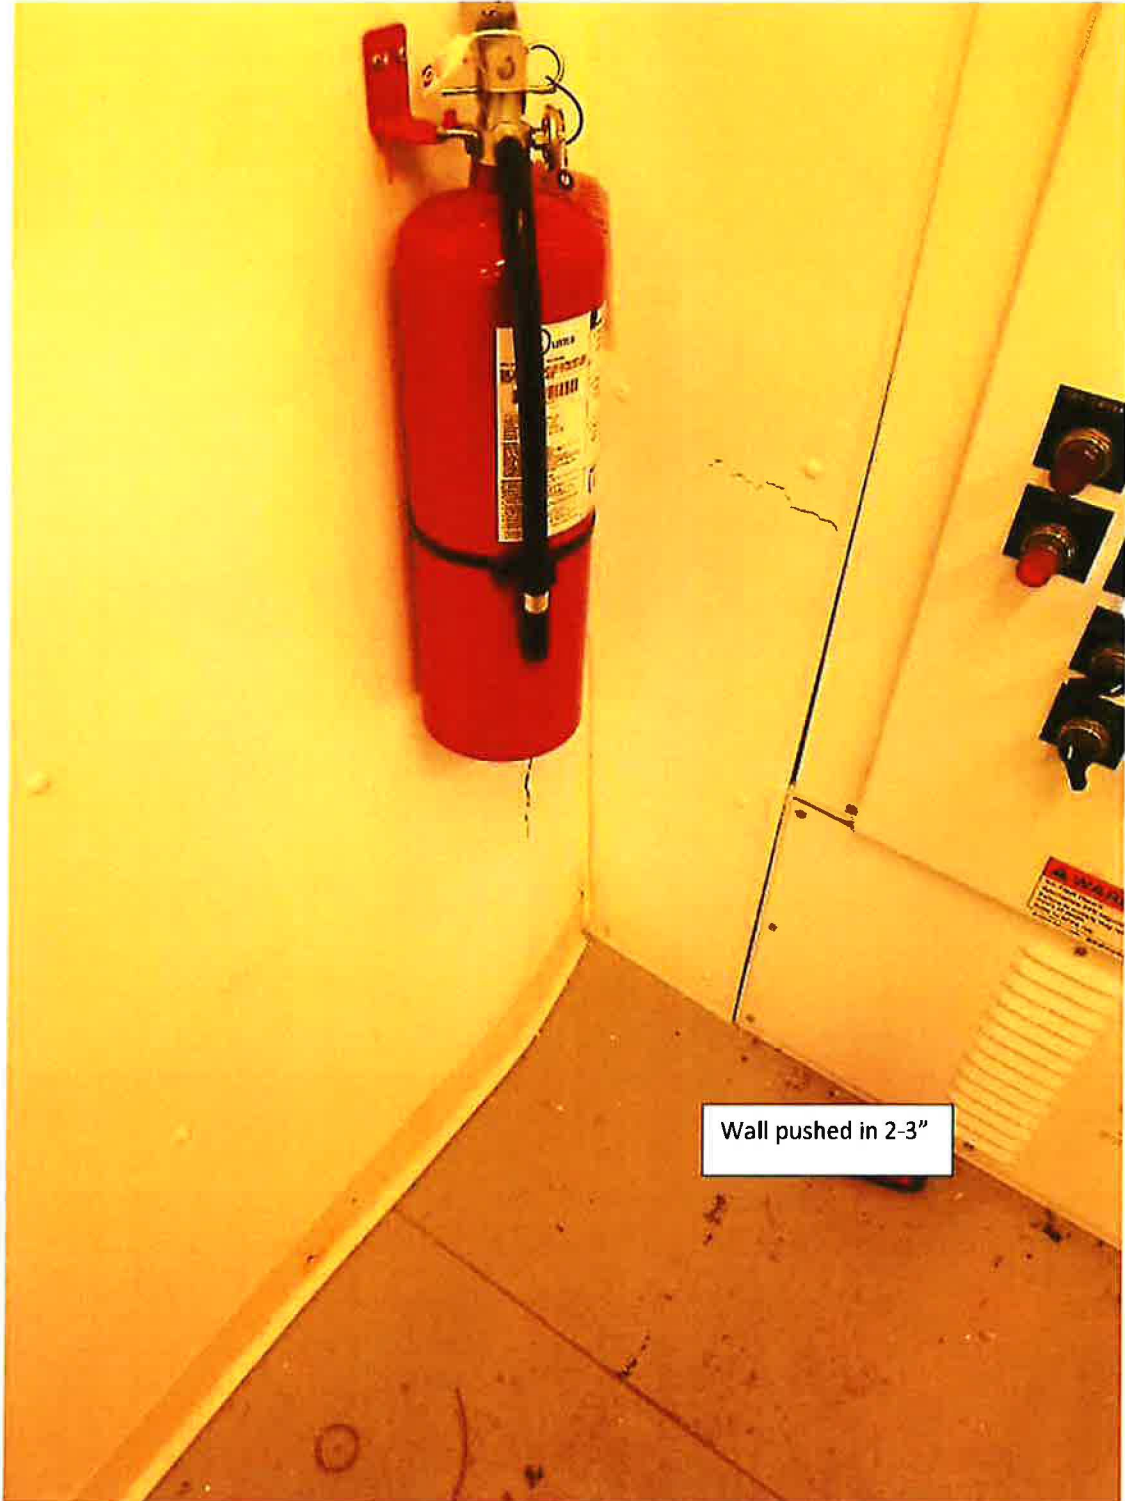
Building shifted on foundation.  
Bracket should be flush.

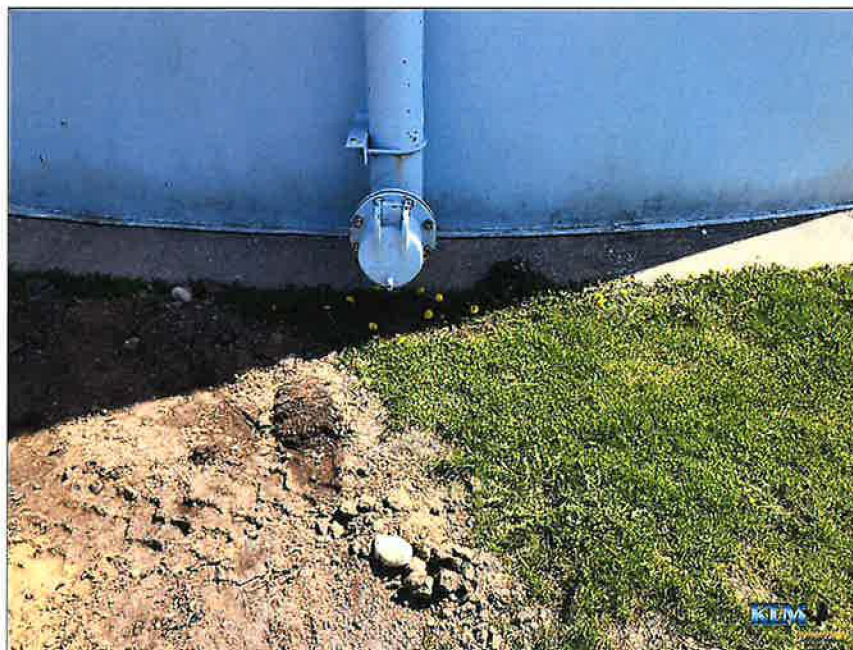
**3.5.1** The exterior coating is in poor overall condition with more than 50 percent visible coating failures throughout the structure. Failures consist of rust nodules caused by deterioration of the topcoat exposing the underlying epoxy to UV conditions. Due to age and condition the exterior is not a candidate for spot repair or over-coating and should be replaced in its entirety at the same time as the interior coating within the next 12 months. This includes the piping in the valve pit. See photos 27 through 41.

Photo No. 38  
Overflow discharge

**3.4.6** Install a splash pad under the overflow discharge to allow for drainage away from the base of the reservoir per AWWA D100-11 requirements. See photos 38 and 39.
